Report No. UT-19.02

## **SURVEYING NON-MOTORIZED TRAVEL BEHAVIOR AT AT-GRADE RAIL CROSSINGS**

Utah Department of Transportation  
Research Division

**Final Report  
March 2019**

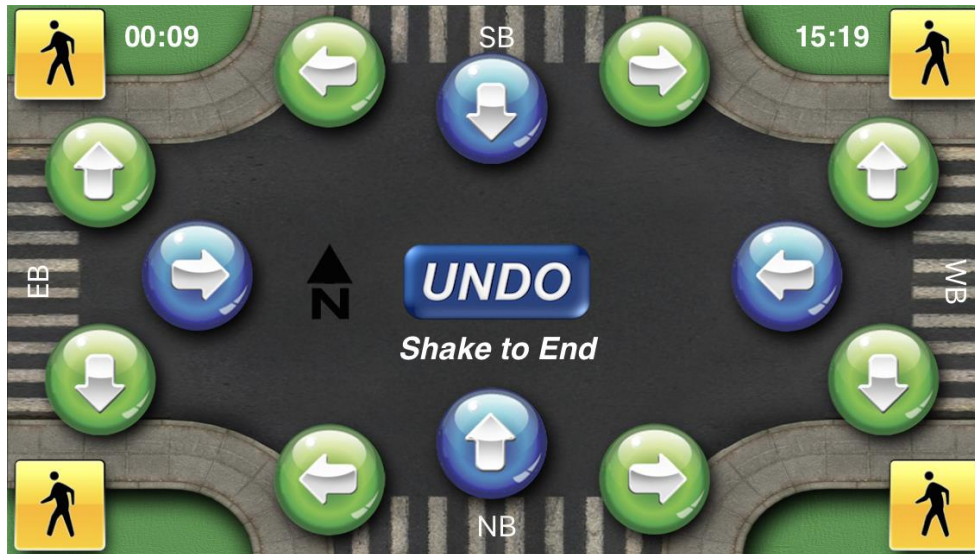
**Figure 2. TurnCount Interface View**

Project staff documented all vehicles and non-motorists who crossed the grade-crossing during the observation window. Counts were documented using the TurnCount Lite application. TurnCount Lite is a simplified version of the full TurnCount app and is intended for use by civil engineers, planning organizations, or others who do not require the complexity provided by the full TurnCount app. The application collects intersection count information with self-populated

date, day and time fields. Data is entered manually using an onscreen keyboard (shown in Figure 2 below).

Vehicular traffic is counted by indicating the movement direction using the green and blue arrows, and non-motorists are counted by swiping the pedestrian icon in the direction of the crossing. When the counts were complete, the data is exported to a .csv file that date/time stamps every recorded movement. This also allowed the project team to identify complex movements, such as a pedestrian crossing the street from one side to another before navigating the rail grade crossing. While this application allowed for improved ease of data collection there was one drawback. The app did not allow for the distinction between pedestrians and cyclists. Therefore, all non-motorists were aggregated into a single non-motorist category.

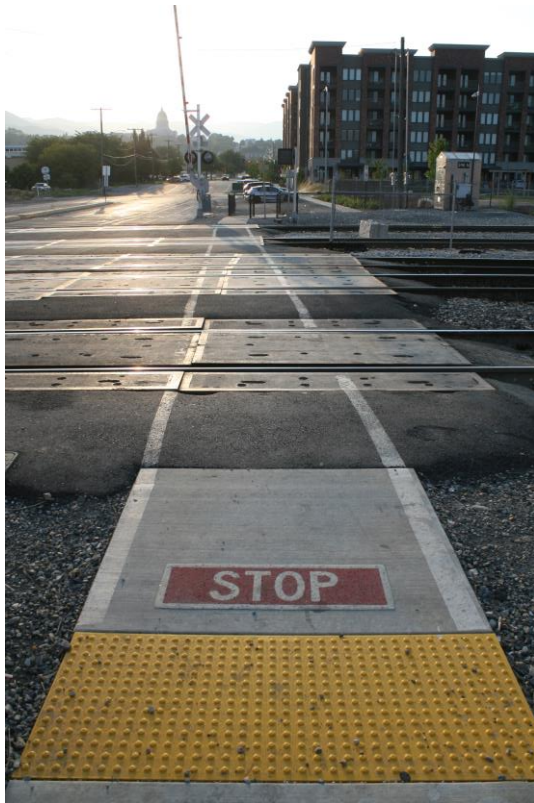
**Figure 3. Detectable Warning Surface and STOP Pavement Marking**

A qualitative observational analysis revealed that a large majority of able-bodied pedestrians actually try to avoid the raised pavement of a DWS (shown in Figure 3 above), walking to one side or another, or stepping over it completely. It is uncertain why this occurs or if it is consciously done, but even individuals who stayed in the appropriate right-of-way seemed to veer to one side of the half-domes or another.

Results show that DWS was once again the only pavement marking correlated to non-motorist behavior at the crossings in the sample. The absence of DWS at a crossing was significantly correlated to a decrease in risky non-motorist behavior. In order to better understand this finding, research staff performed two short (45-minute) follow-up visits to crossings included in the sample.
